Over the years, wear has caused some Fourwinds II hubs to lose balance and wobble. To compensate for the wear we recommend the following procedure to place two set screws in the hub, 90° apart, to steady the hub on the shaft.

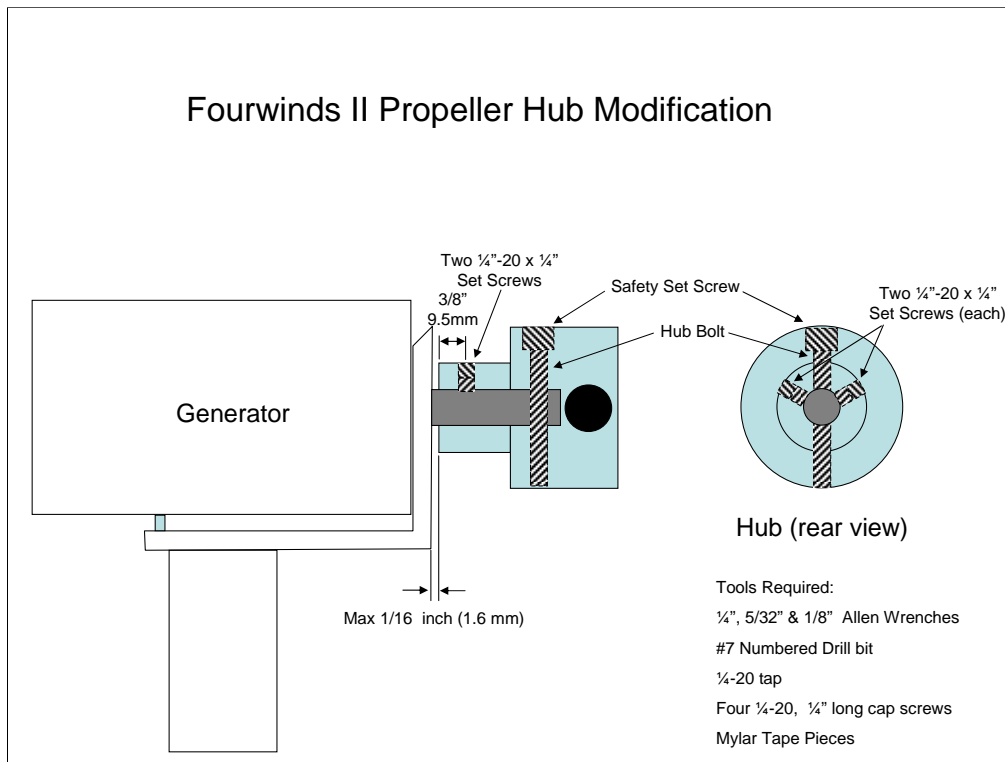
Clean any grease from the shaft opening and stuff a piece of paper towel in the hole. This will help prevent drill filings from falling into the hole. Looking at the rear of the hub (see Hub Modification diagram) with the hub bolt opening at the 12 o'clock position, drill two holes using a #7 numbered drill bit angled 45° on each side of the hub bolt center line (see Hub Rear View for orientation). The holes should be placed 3/8" (9.5 mm) from the rear of the hub assembly. Tap each hole with a 1/4-20 tap. Remove the paper towel and insure there are no metal filings in the hub shaft opening. Clean the generator shaft and give it a light coat of Lanocote grease. Place the hub back on the shaft and reinstall the hub bolt and the safety set screw. In each of the new holes, using an 1/8" Allen wrench, insert a 1/4" long 1/4-20 set screw. Tighten them evenly. Once they are tightened down, insert a second 1/4" long 1/4-20 set screw to prevent the first from coming loose. We recommend *not* using Loctite on these screws. Cover all openings with Mylar tape for protection against moisture.

Remove the Mylar tape that protects the safety set screw for the hub bolt. Using a 1/4" Allen wrench, back out the set screw to expose the hub bolt. Using a 5/32" Allen wrench, remove the hub bolt and separate the propeller hub assembly from the generator.
